A simulated bushfire test report

An external construction tested in accordance with AS 1530.8.1:2007

Products: Brite Decking WPC Traditional Solid Deck Boards

Job number: FRT200102

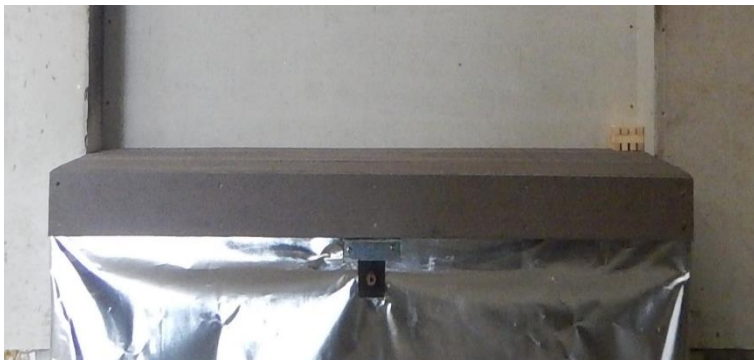
Item	Description	
Deck		
1	Name	Brite Decking WPC Traditional Solid decking boards
	Size	137 mm wide x 23 mm thick (measured)
	Linear Density	Nominal 4.3 kg/m (measured)
	Installation	Positioned on the top side of the joists parallel to the wall system. There was a gap of nominal 1.9 mm between the boards (spaced using Brite Decking WPC hidden fastener and screw system). The fascia consisted of a full width Brite Decking WPC fascia board.
2	Fixing	The decking boards were secured using screws (item 2) at every joist (Item 5) and spaced using the Brite Decking WPC hidden fasteners (item 4). The fascia board was secured using 2-off screws (item 3) spaced at every joist, 30 mm from the upper and lower edges of the board.

3	Name	Decking screws
	Description	6g x 35 mm long countersunk head needle point coarse thread screws
	Installation	1-off screw used in conjunction with the Brite Decking WPC hidden fastener (item 4) to secure the decking boards (Item 1) to each joist.

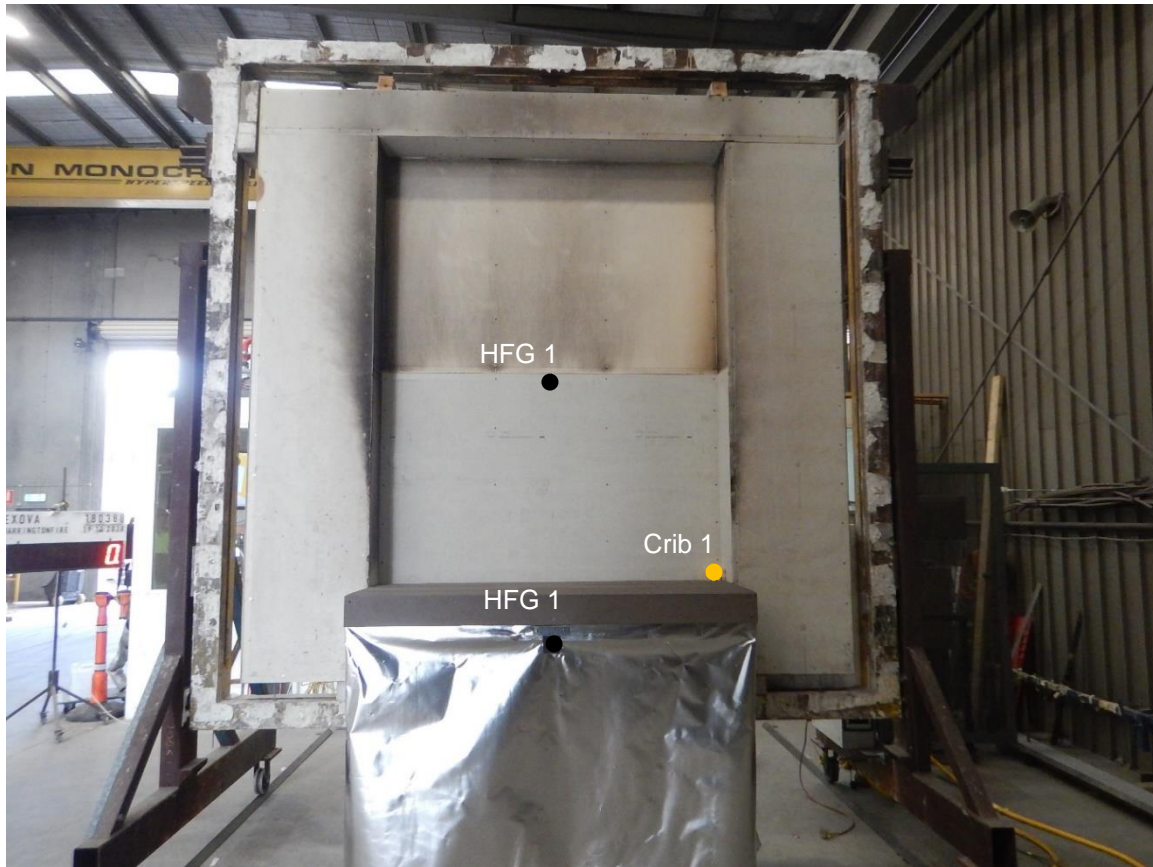
Figure 4 Indicative heat flux gauge locations (exposed side shown)

- Southern crib located at the south east corner of the deck
- Black dots indicate heat flux gauge location.
- Orange dots indicate crib location.

Location	Ref	Description
Fascia	HFG1	Located centrally across the deck, a nominal 50 mm below the bottom of the deck.
Wall	HFG2	Located centrally to the wall, on the exposed face.
